# Nano-Cathedral

# D1.4 – Report on decay phenomena

Deliverable n°	D1.4		
Deliverable title	Report on decay phenomena		
WP no.	1		
WP Leader	Marco Lezzerini (INSTM)		
Contributing Partners	CONSORZIO INTERUNIVERSITARIO NAZIONALE PER LA SCIENZA E TECNOLOGIA DEI MATERIALI, Opera della Primaziale Pisana, MBAC, HDK, UNI BA, Fundación Catedral Santa María, DIPUTACIÓN FORAL DE ÁLAVA, Dombausekretariat St.Stephan, UNIVERSITAT FUR ANGEWANDTE KUNST WIEN, TU WIEN, Architectenbureau Bressers, Statsbygg		
Nature	confidential		
Authors	Luciana Festa, Angelica Pujia		
Contributors	Marco Lezzerini, Michele Marroni, Francesca Signori         Gianluca De Felice, Anton Sutter, Donatella De Bonis, Roberto Cela         Marco Bartolini, Lucia Conti, Marcella Ioele, Giancarlo Sidoti         Ulrike Brinckmann, Sven Eversberg, Peter Fuessenich, Sophie Hoepner         Rainer Drewello         Leandro Camara, Juan Ignacio Lasagabaster         Santiago Tamayo, Blanca Narbona Villa, Cristina Aransay Saura         Wolfgang Zehetner, Franz Zehetner         Johannes Weber, Anthony Baragona, Elisabeth Ghaffari         Andreas Rohatsch, Matea Ban         Ignace Roelens, Matthias De Waele, Philippe Depotter, Maarte

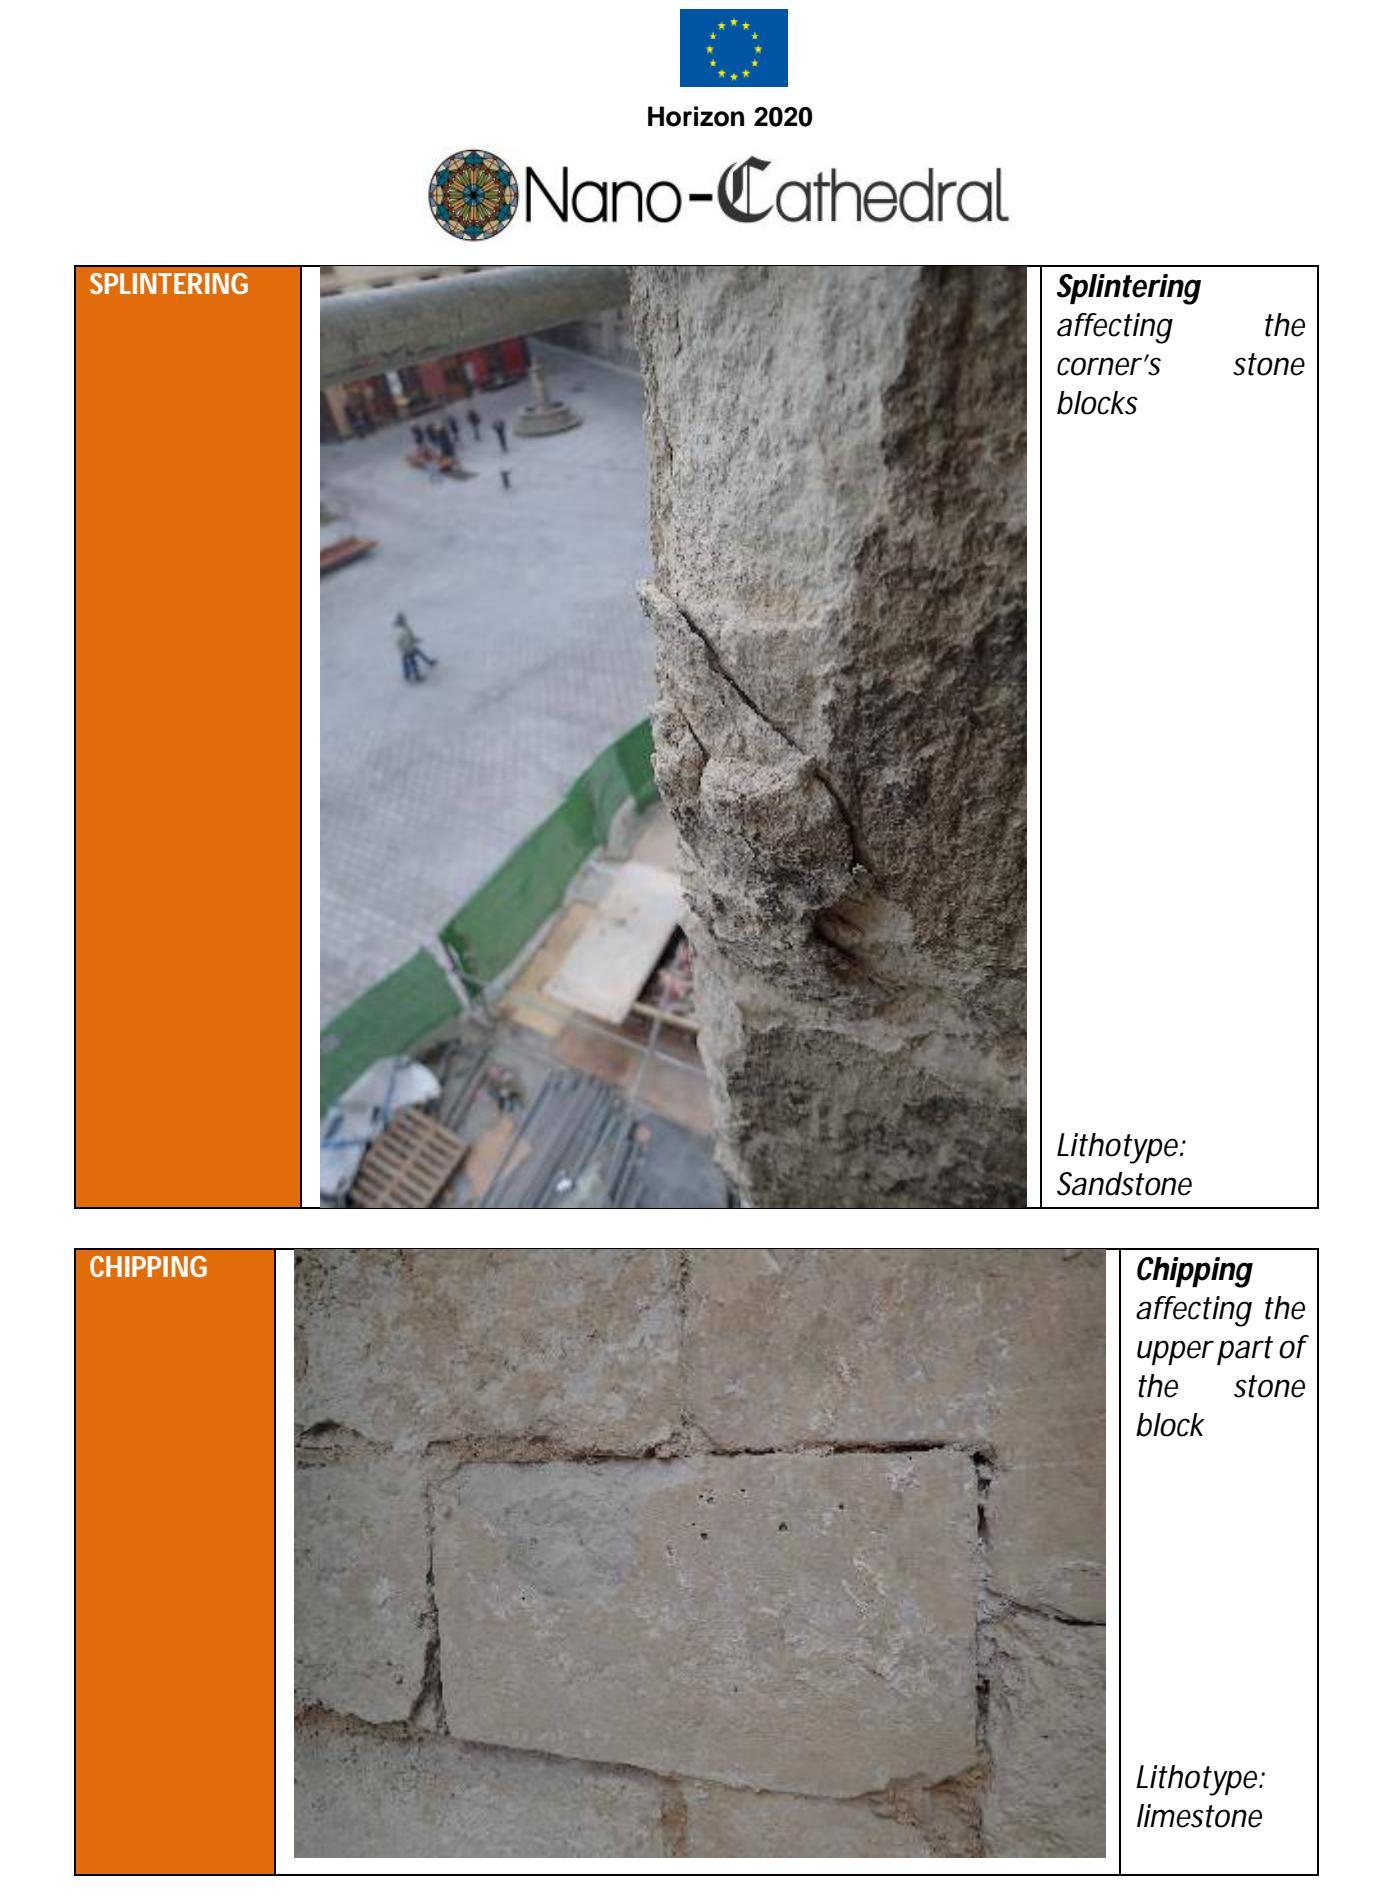
CRUMBLING	Disitntegration affecting the whole stone block Lithotypes: limestone/ sandstone	
SPLINTERING	Splintering affecting the corner stone blocks
