## Science and Art: A Future for Stone

# ARTIFICIAL AGEING TECHNIQUES ON VARIOUS LITHOTYPES FOR TESTING OF STONE CONSOLIDANTS

M. Ban<sup>1\*</sup>, A.J. Baragona<sup>2</sup>, E. Ghaffari<sup>2</sup>, J. Weber<sup>2</sup> and A. Rohatsch<sup>1</sup>

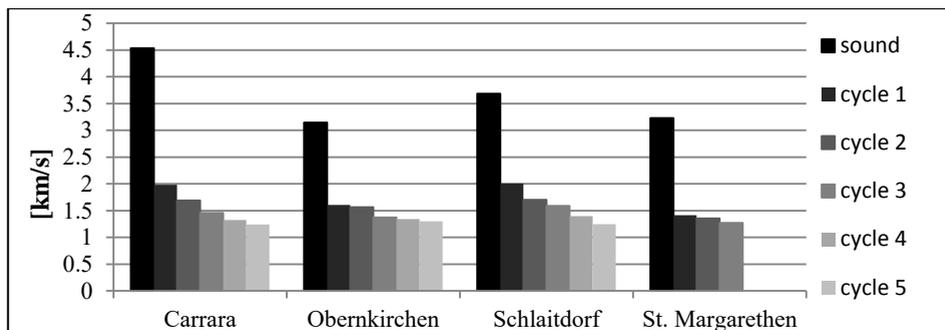
Fig. 1: Mean value of ultrasound pulse velocity after 5 cycles of heat treatment.

The evaluation of an aged stone's soundness by ultrasound pulse velocity shows the most significant drop after the first heat cycle but in the case of marble and the two silicates the velocity continues to decrease after additional cycles (Fig. 1). A stable state occurs after the 5<sup>th</sup> cycle. For St. Margarethen and very often also for Obernkirchen only 3 cycles are necessary to reach the lowest possible values. For the latter 3 cycles are likely to cause the failure of the sample. While some of the results may seem unrealistically low, for the testing of stone consolidants the lowest values should be taken even though in real life this condition indicates the danger of breakdown and the stones would either be replaced or put in a controlled environment (Siegesmund and Dürrast 2014). The highest possible deviation between sound and aged specimens make it possible to describe more accurately the difference of mechanical and physical properties of the stones and the performance of the consolidant.

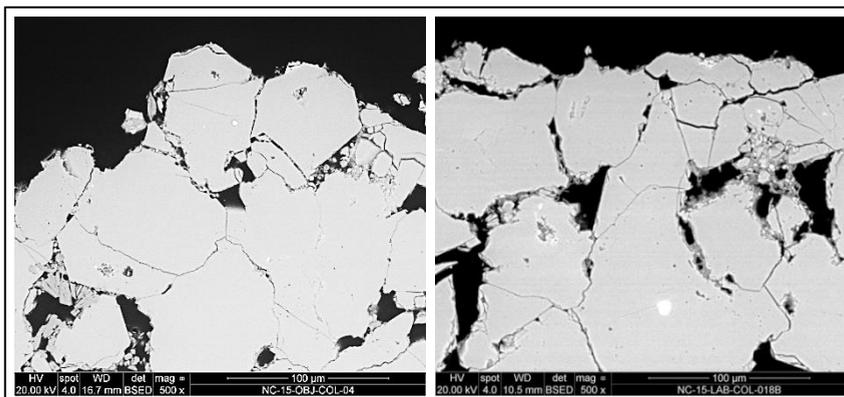
Fig. 2: Naturally (left) - compared to artificially aged (right) Obernkirchen Sandstone.

The reasons for decay can be observed by scanning electron microscopy. The fissures created can be compared to the ones found in-situ (Fig. 2). The only difference is that the artificially induced cracks range through the whole specimens and are quite homogenous while the naturally developed occur only in exposed surfaces. While inter- and intra-granular fractures can be observed in the whole specimen, the natural decay phenomena show cracks parallel to the surface and thus contour scaling of different depths. Moreover the naturally decayed specimens show hollow spaces in a range of 10  $\mu\text{m}$  up to 1 mm and the same effect can be achieved through thermal treatment. These effects are created due to the reduction of kaolin cement, some of which has been converted to meta-kaolin and re-deposited away from the grain boundaries and the formation of fissures within the silica grains (Fig. 2). On St. Margarethen calcareous arenite it is observable that the first heating results in the increase in porosity while re-heating the stone shows only minimal changes. This is due to the formation of micro-cracks that can accommodate more calcite crystals
