# Nano-Cathedral

# D1.4 – Report on decay phenomena

Deliverable n°	D1.4		
Deliverable title	Report on decay phenomena		
WP no.	1		
WP Leader	Marco Lezzerini (INSTM)		
Contributing Partners	CONSORZIO INTERUNIVERSITARIO NAZIONALE PER LA SCIENZA E TECNOLOGIA DEI MATERIALI, Opera della Primaziale Pisana, MBAC, HDK, UNI BA, Fundación Catedral Santa María, DIPUTACIÓN FORAL DE ÁLAVA, Dombausekretariat St.Stephan, UNIVERSITAT FUR ANGEWANDTE KUNST WIEN, TU WIEN, Architectenbureau Bressers, Statsbygg		
Nature	confidential		
Authors	Luciana Festa, Angelica Pujia		
Contributors	Marco Lezzerini, Michele Marroni, Francesca Signori         Gianluca De Felice, Anton Sutter, Donatella De Bonis, Roberto Cela         Marco Bartolini, Lucia Conti, Marcella Ioele, Giancarlo Sidoti         Ulrike Brinckmann, Sven Eversberg, Peter Fuessenich, Sophie Hoepner         Rainer Drewello         Leandro Camara, Juan Ignacio Lasagabaster         Santiago Tamayo, Blanca Narbona Villa, Cristina Aransay Saura         Wolfgang Zehetner, Franz Zehetner         Johannes Weber, Anthony Baragona, Elisabeth Ghaffari         Andreas Rohatsch, Matea Ban         Ignace Roelens, Matthias De Waele, Philippe Depotter, Maarte

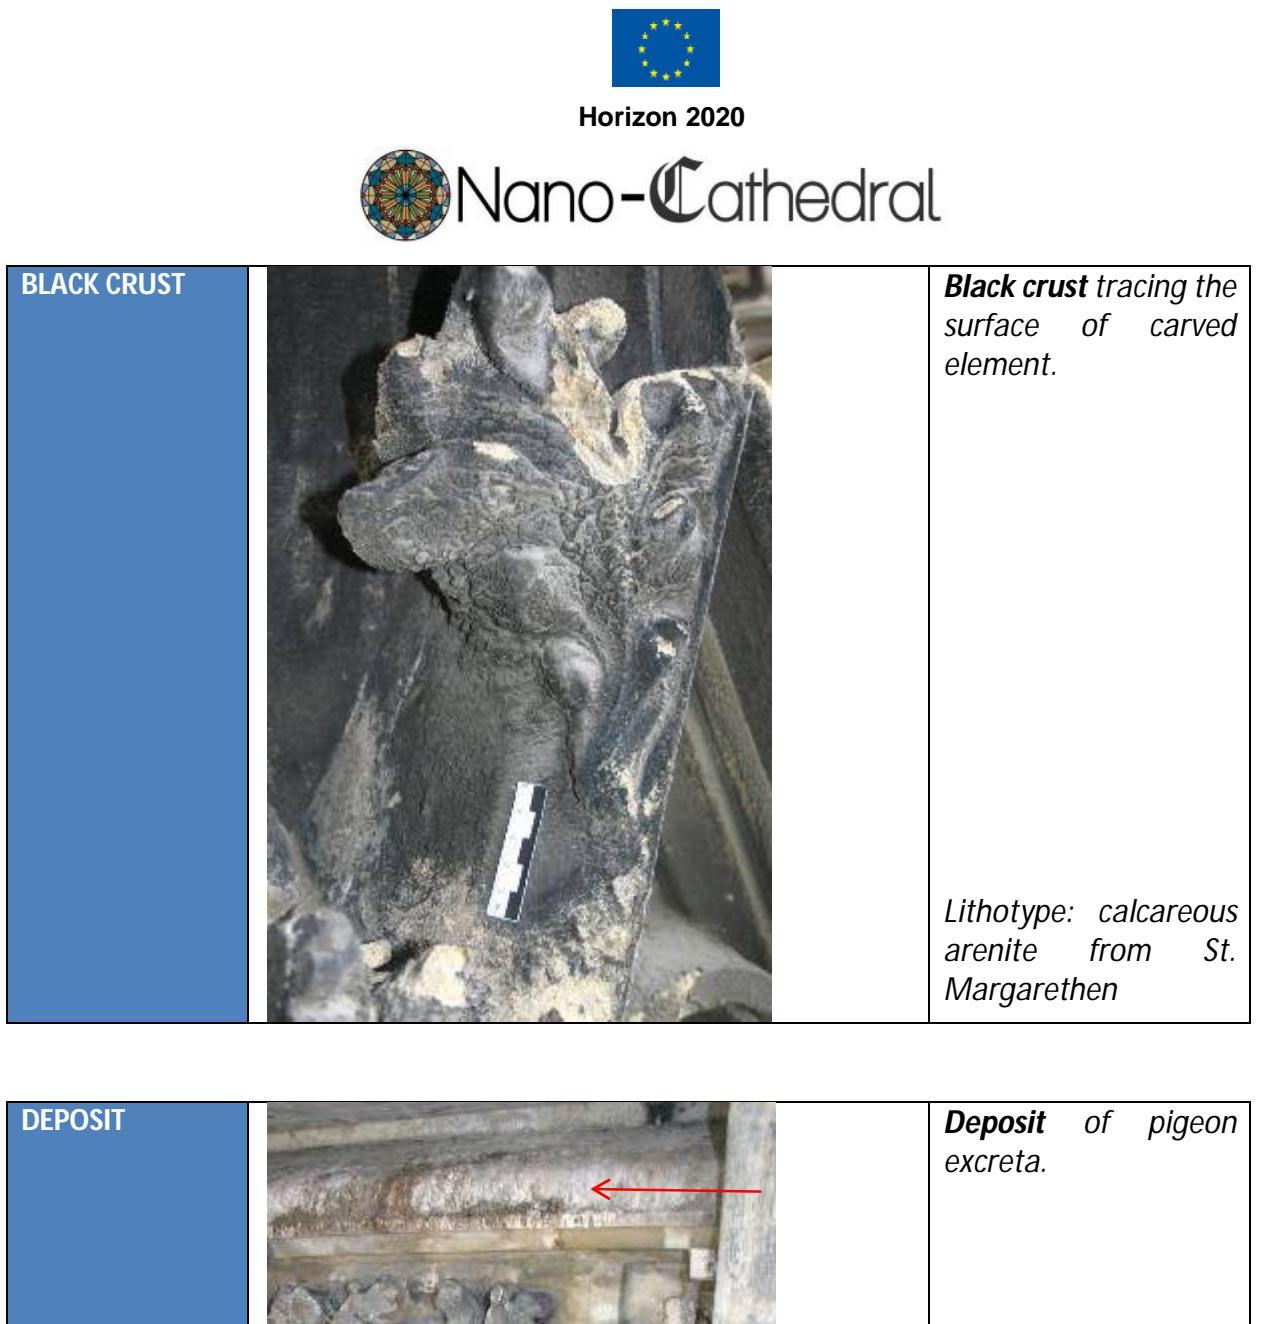
DEPOSIT		<b>Deposit</b> of pigeo	ו
	X STR		ļ
			ļ
	A CONTRACT		ļ
	A RESIDAL		ļ
			ļ
	EC SER	Lithotype:	
		Au limestone

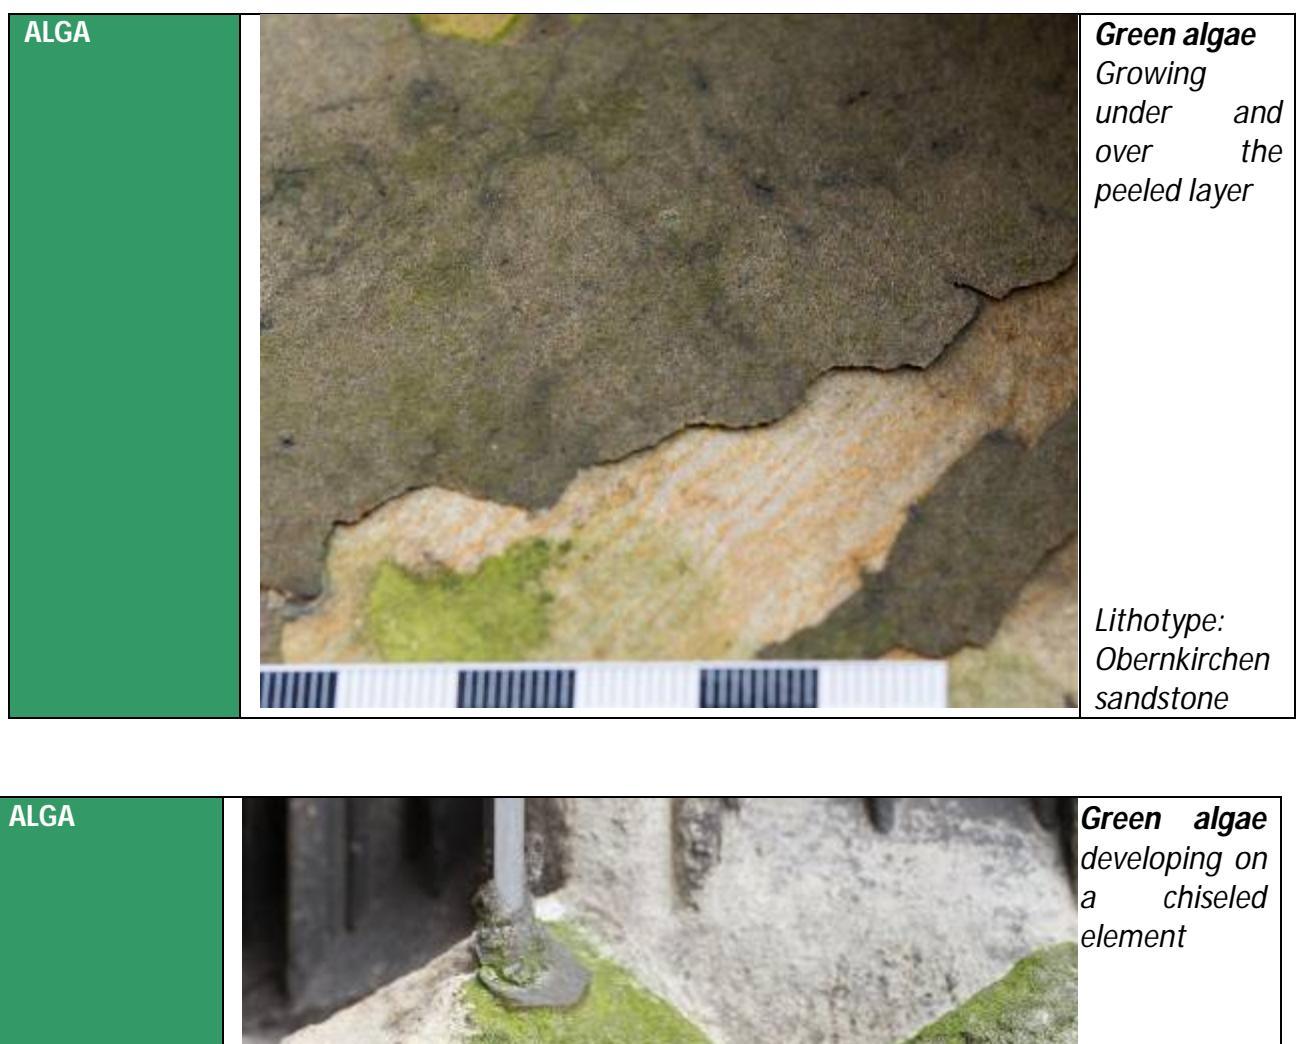
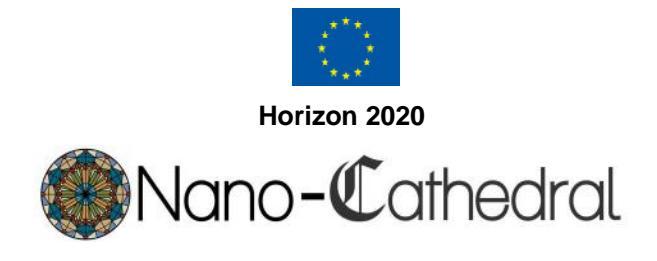
Lithotype: Tercé limestone

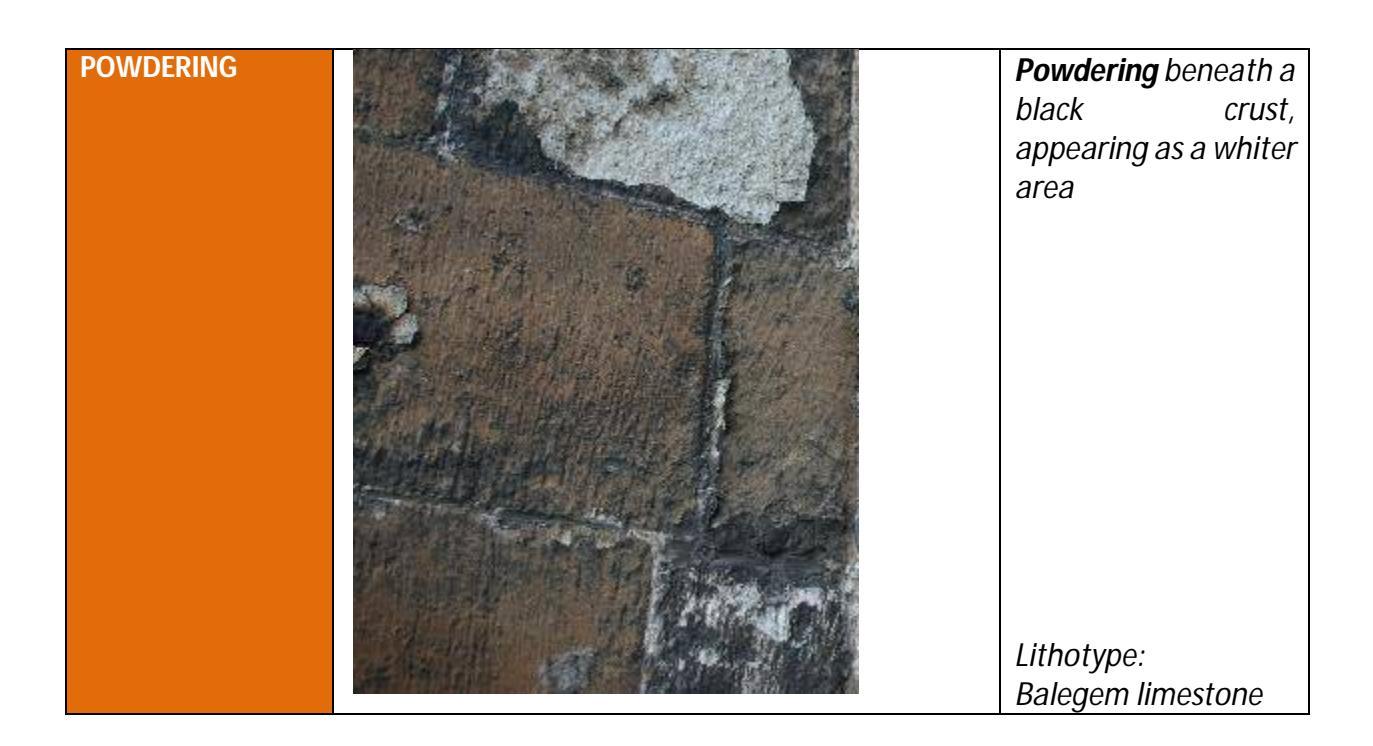
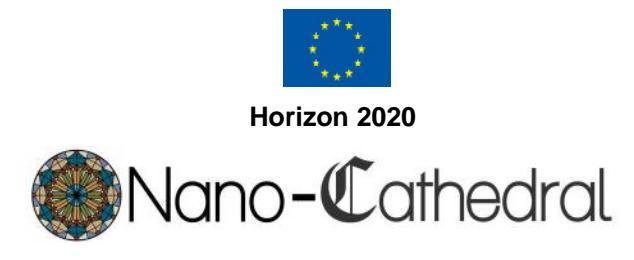
POWDERING
Powdering beneath a black crust, appearing as a whiter zone under the black crust.

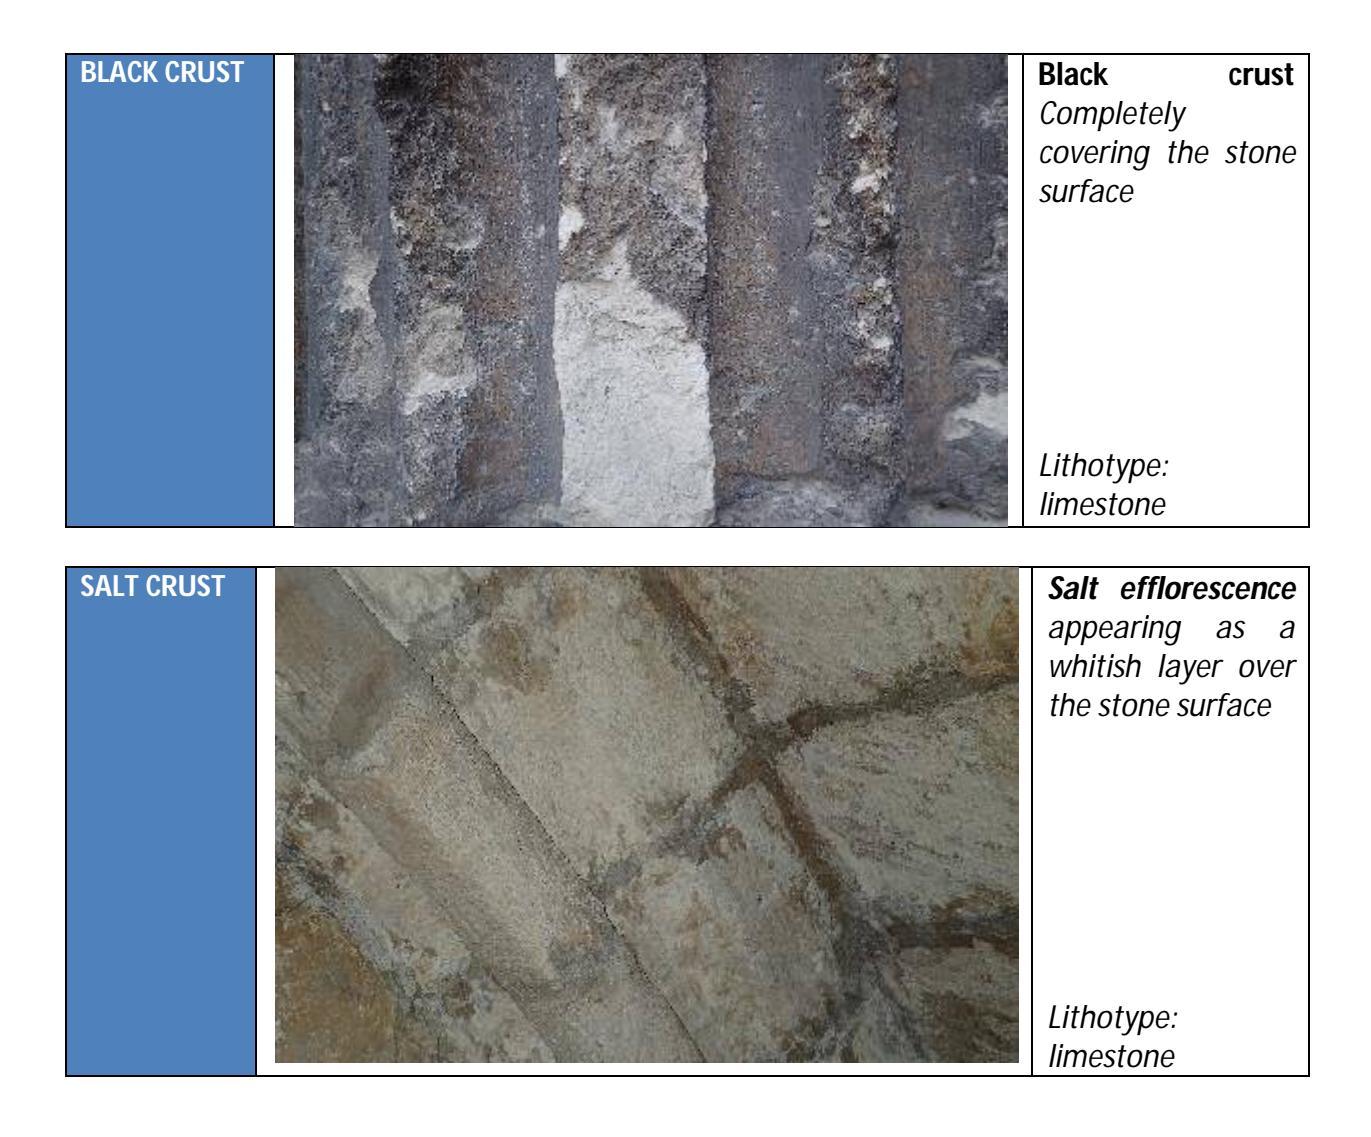
SALT CRUST	Salt efflorescence
	Lithotype: limestone
DEPOSIT	<b>Deposit</b> located in an area away from rain fall
	Lithotype: limestone

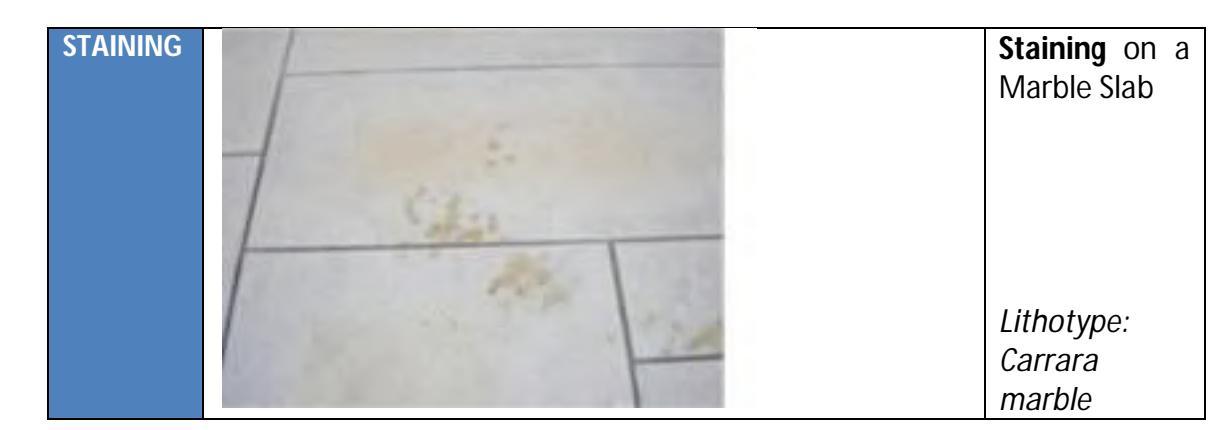
STAINING	Staining
	Lithotype: Carrara marble
